Intel[®] Mobile Pentium[®] III Processor Specification Update

Release Date: December 2000

Order Number: 245306-014

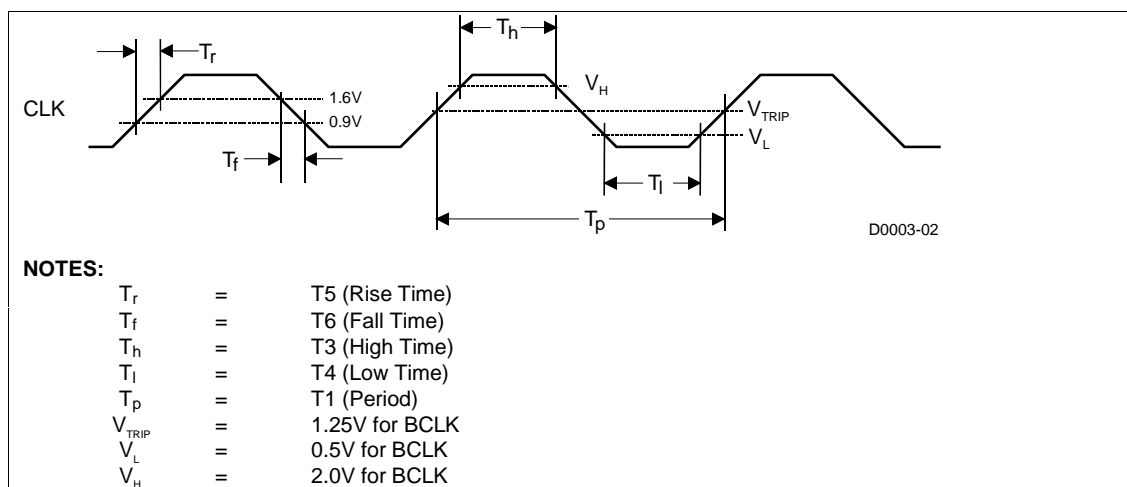
Figure 7. BCLK Timing Waveform

1. All AC timings for GTL+ and CMOS signals are referenced to the BCLK rising edge at 1.25V. All CMOS signals are referenced at 0.75V.
2. The BCLK period allows a +0.5 ns tolerance for clock driver variation.
3. Not 100% tested. Specified by design/characterization.
4. Measured on the rising edge of adjacent BCLKs at 1.25V. The jitter present must be accounted for as a component of BCLK skew between devices.

For B0 step processors, the $V_{IH,BCLK}$ Min spec is changed to 2.0V (from 1.7V for A2 step) and $V_{IL,BCLK}$ Max spec is changed to 0.5V (from 0.7V for A2 step). Due to this, new values are specified for BCLK high and low times for B0 step processors. These modifications affect corresponding specs in Table 13, Table 14, Table 24, and Figure 7 in *Mobile Pentium® III Processor in BGA2 and Micro-PGA2 Packages datasheet* (Order Number 245302-002).

Symbol	Parameter	Min	Typ	Max	Unit	Figure	Notes
	System Bus Frequency		100		MHz		
T1	BCLK Period		10		ns	Figure 7	Note 2
T2	BCLK Period Stability			± 250	ps		Notes 3, 4
T3	BCLK High Time	2.70			ns	Figure 7	at >2.0V
T4	BCLK Low Time	2.45			ns	Figure 7	at <0.5V
T5	BCLK Rise Time	0.175		0.875	ns	Figure 7	(0.9V – 1.6V)
T6	BCLK Fall Time	0.175		0.875	ns	Figure 7	(1.6V – 0.9V)
